# Planning, Design, and Construction of Hokersar Gates and Rejuvenation of Hokersar Wetland

# **Workshop Series**

Presented by: Er. Zaffar Mustaffa Khan, Executive Engineer, FSC Narbal

30<sup>th</sup> August 2024

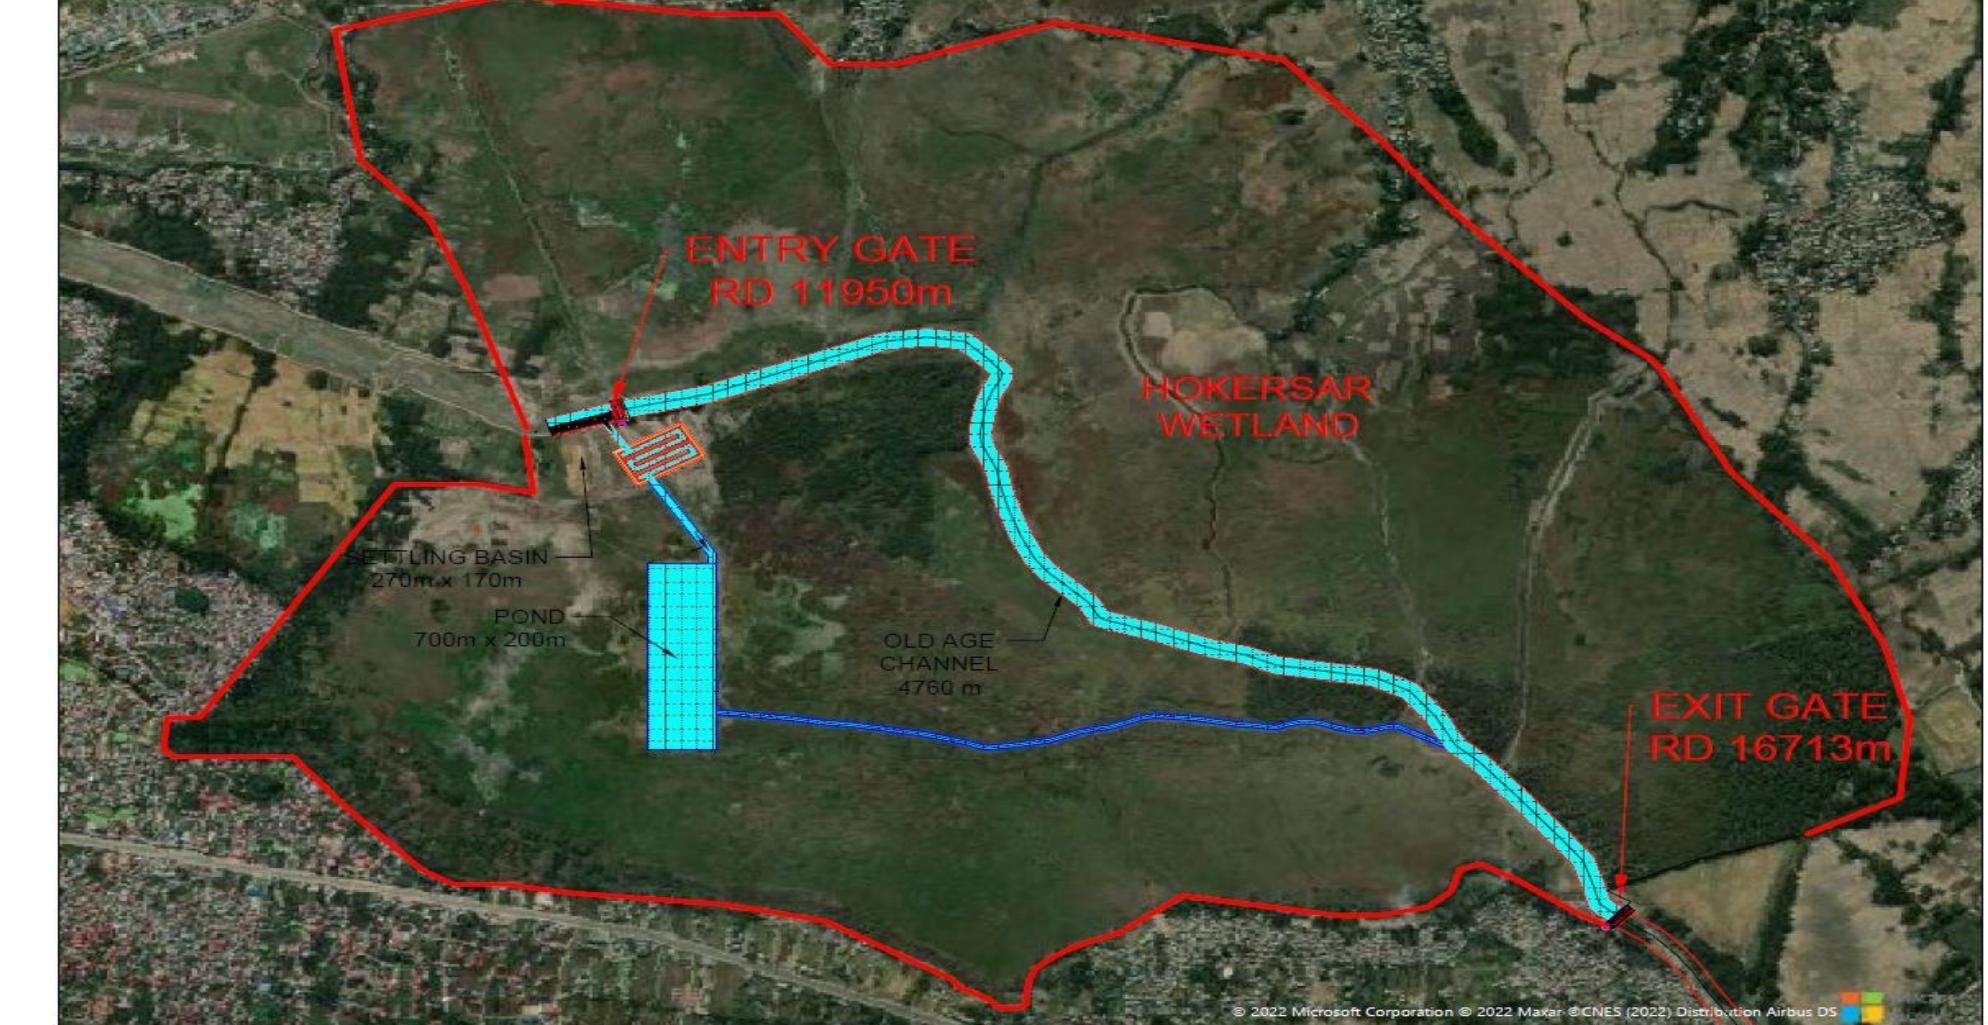
•FSC Origin: Takes off from River Jehlum near Padshahibagh, Srinagar.

•Route: Enters Hokersar near Zainakote Srinagar and exits upstream of Narbal bridge.

•FSC is a crucial water source for replenishing Hokersar.

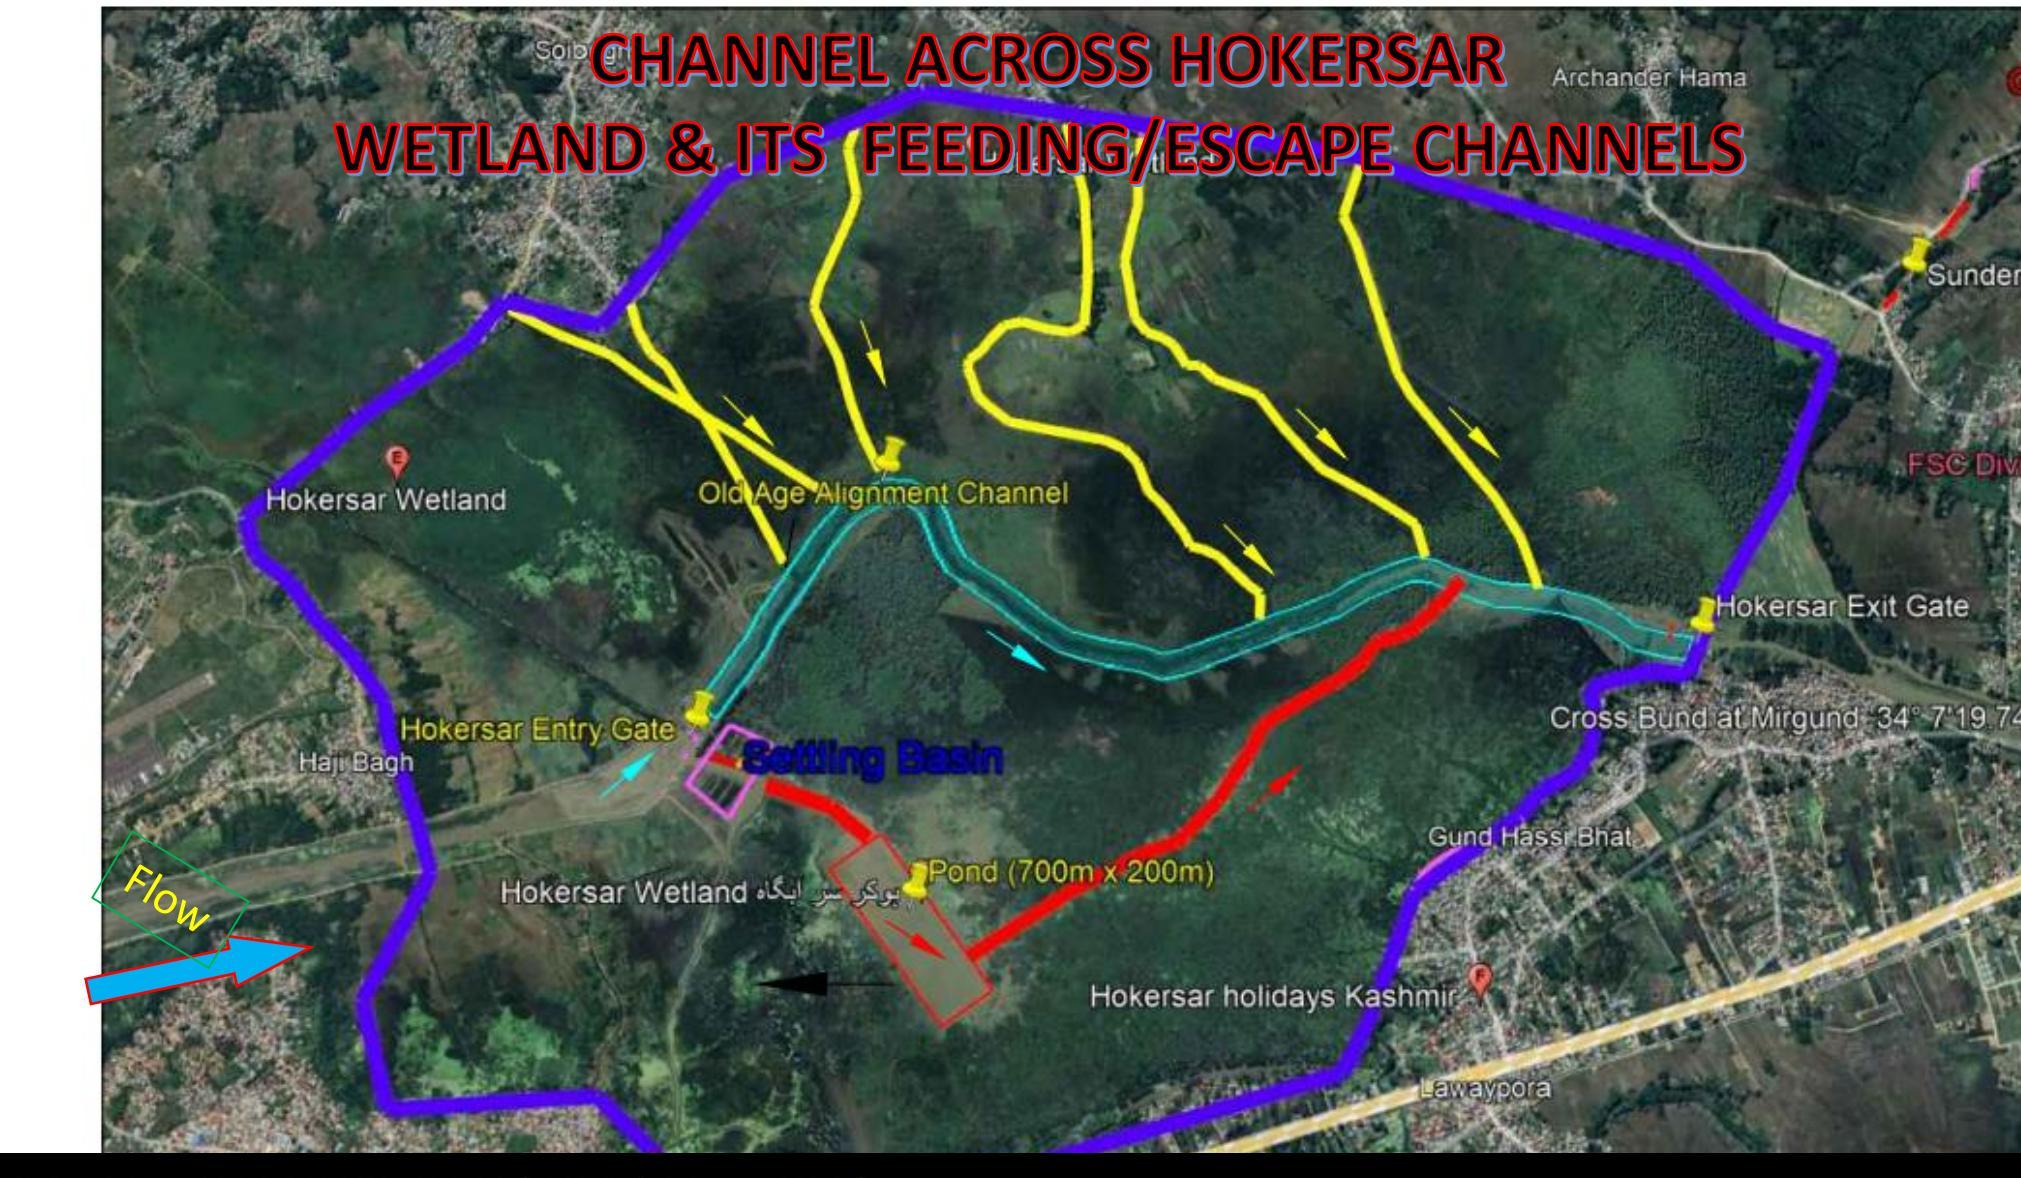
LENGTH OF MAIN CHANNEL IN HOKERSAR- 4749m LENGTH OF FEEDING NALLAHS - 10766 m LENGTH OF DIVERSION CHANNEL DURING LEAN PEROID- 2677 m SIZE OF RETENTION POND - (700X200)m

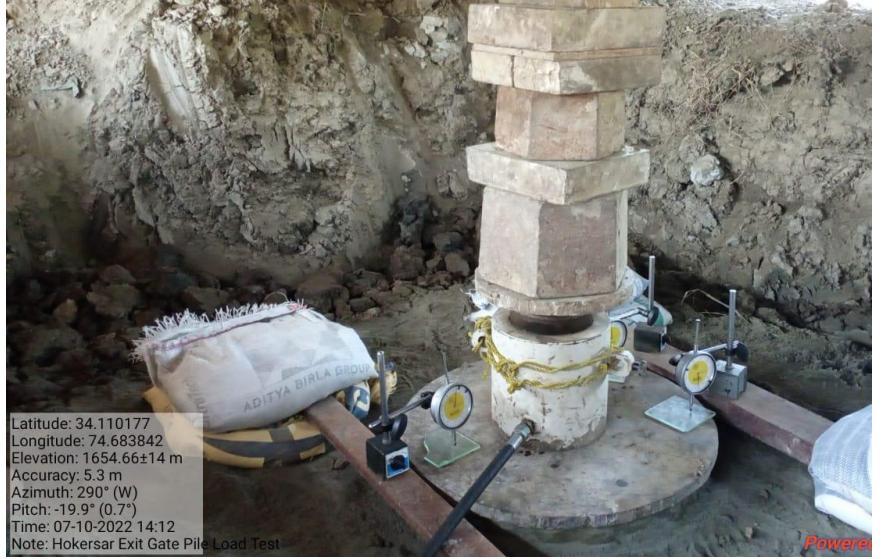
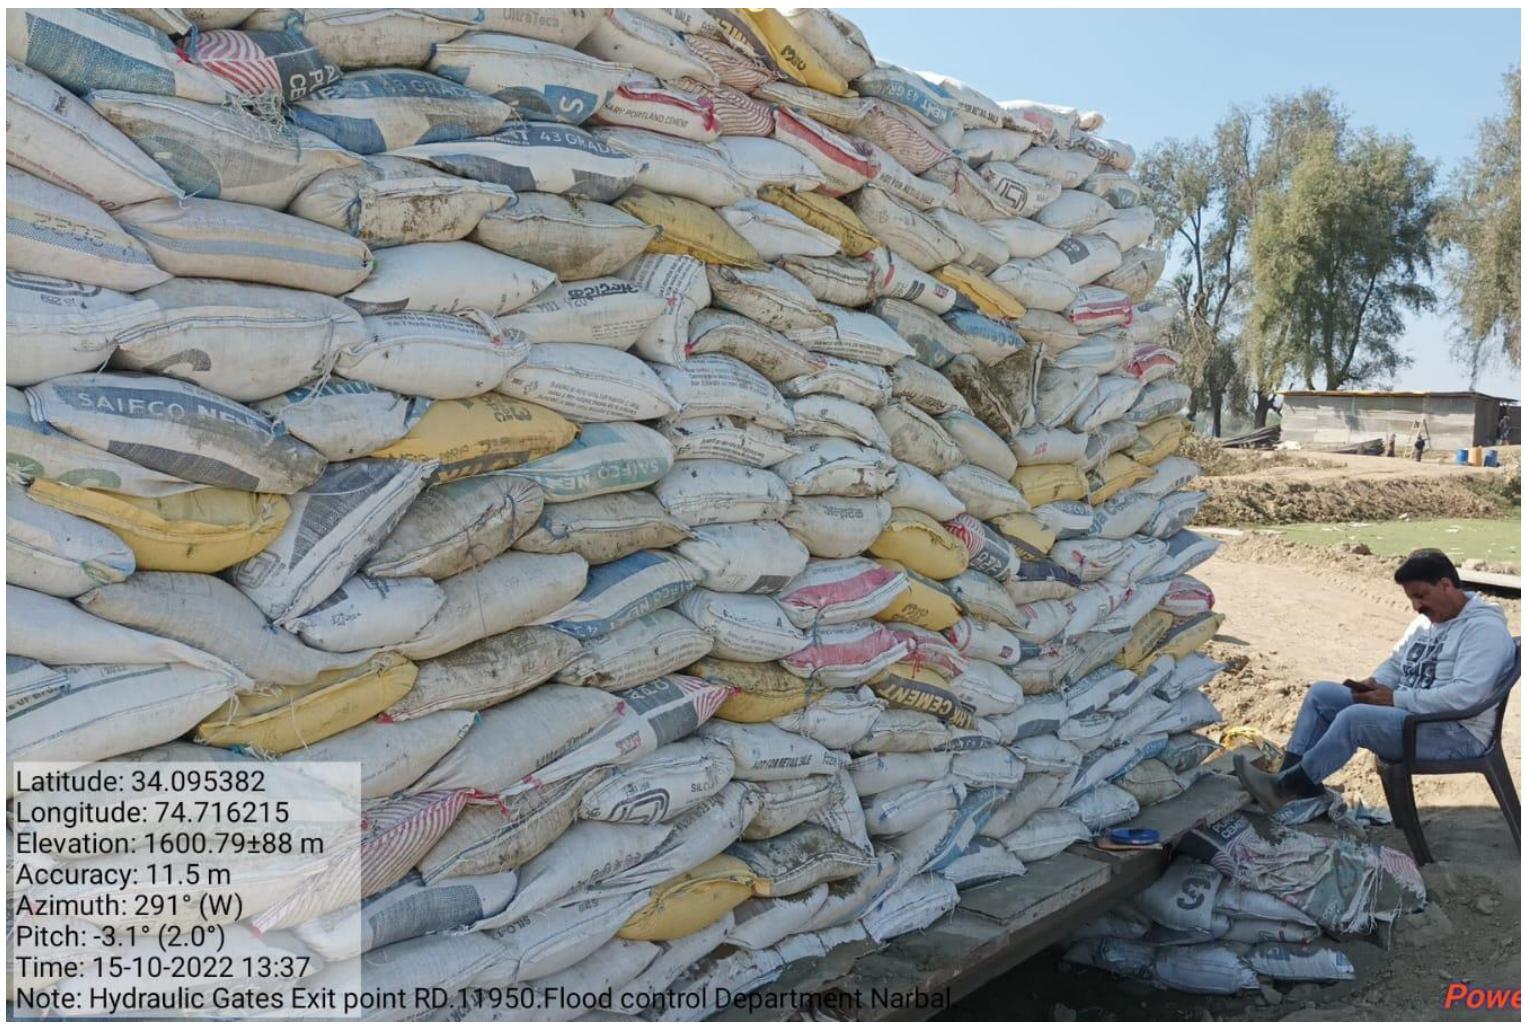
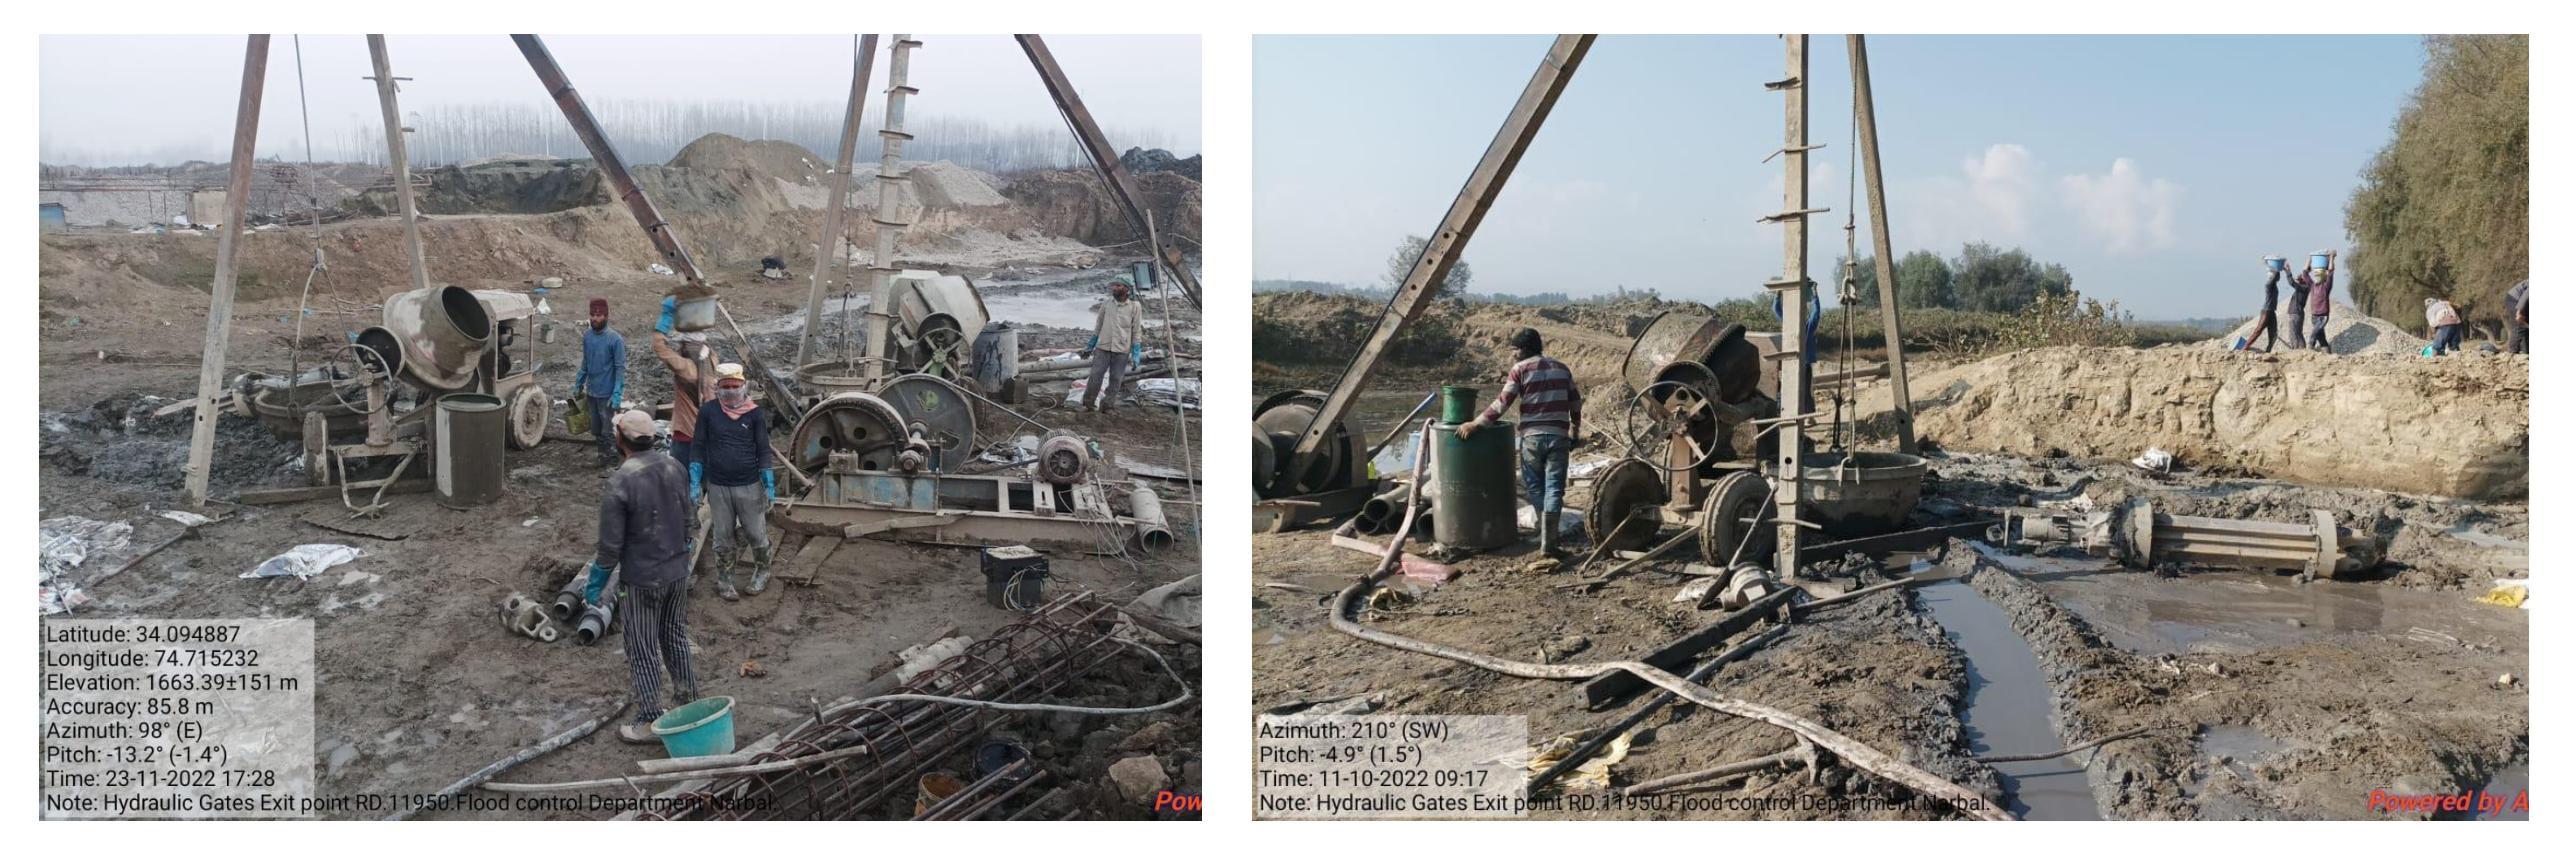
# **Pile Work Execution**

- The pile foundation involved drilling and installing 300No piles of length 21mtr with a diameter of 600mm to support the structure.
- Comprehensive load tests confirmed the piles capacity to bear required loads, ensuring structural integrity.

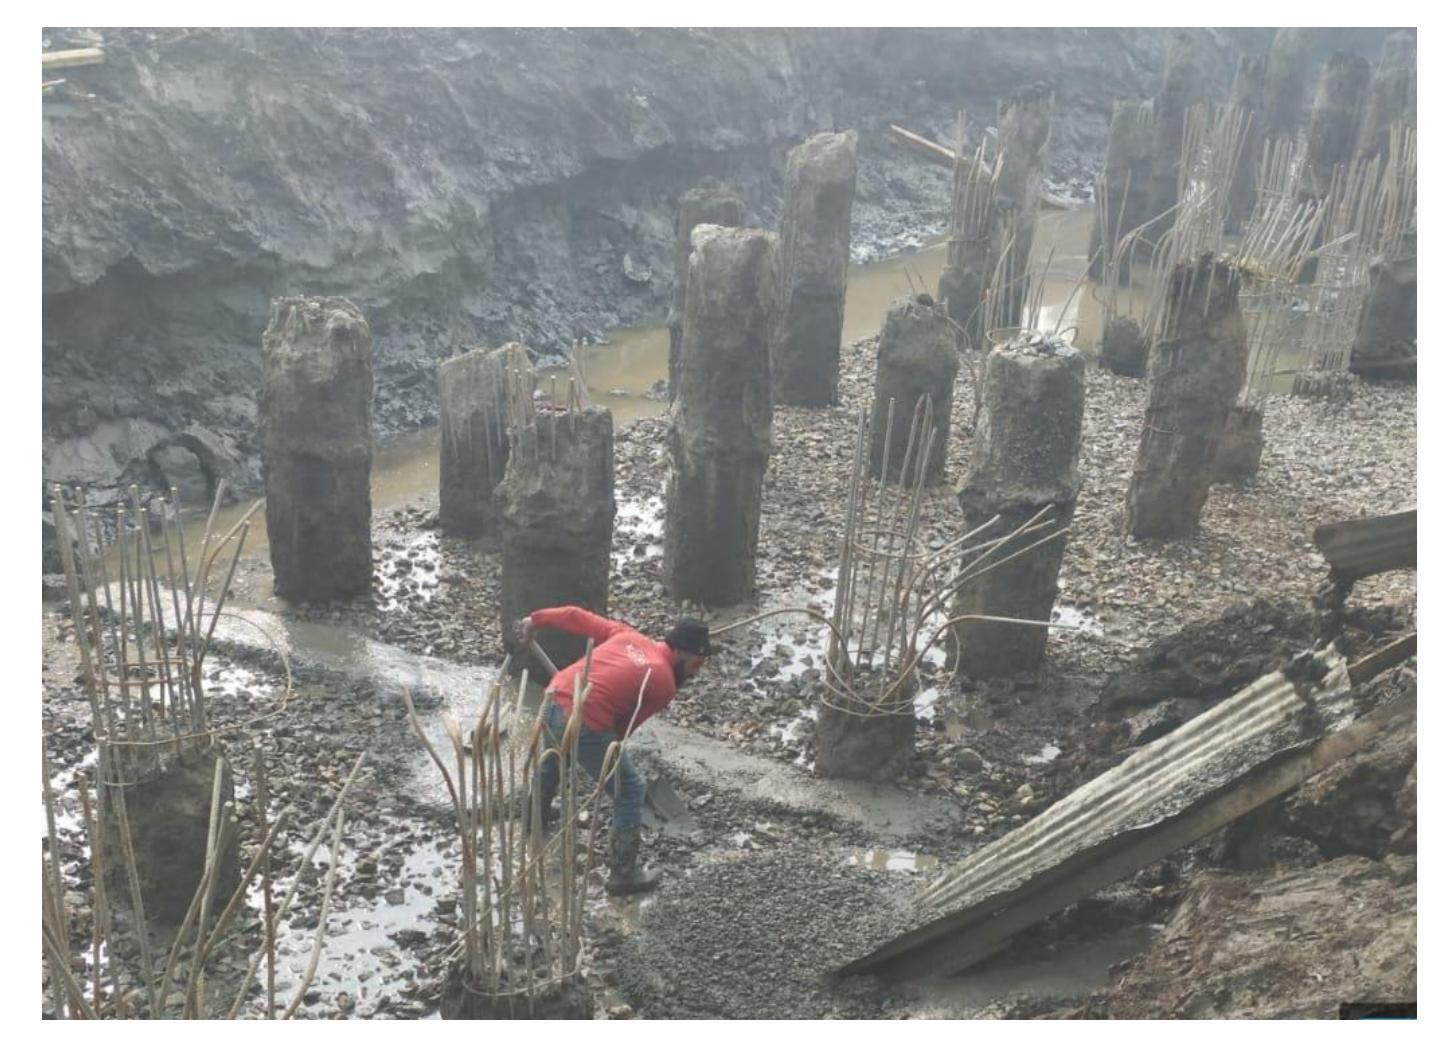
# Construction of Pile Caps

•After pile installation, pile caps were constructed, involving chipping of RCC pile heads, placing reinforcement bars, and performing mass concreting.

•Each pier pile cap is supported by a group of 6 piles.

•Building pile caps include 2 piles.

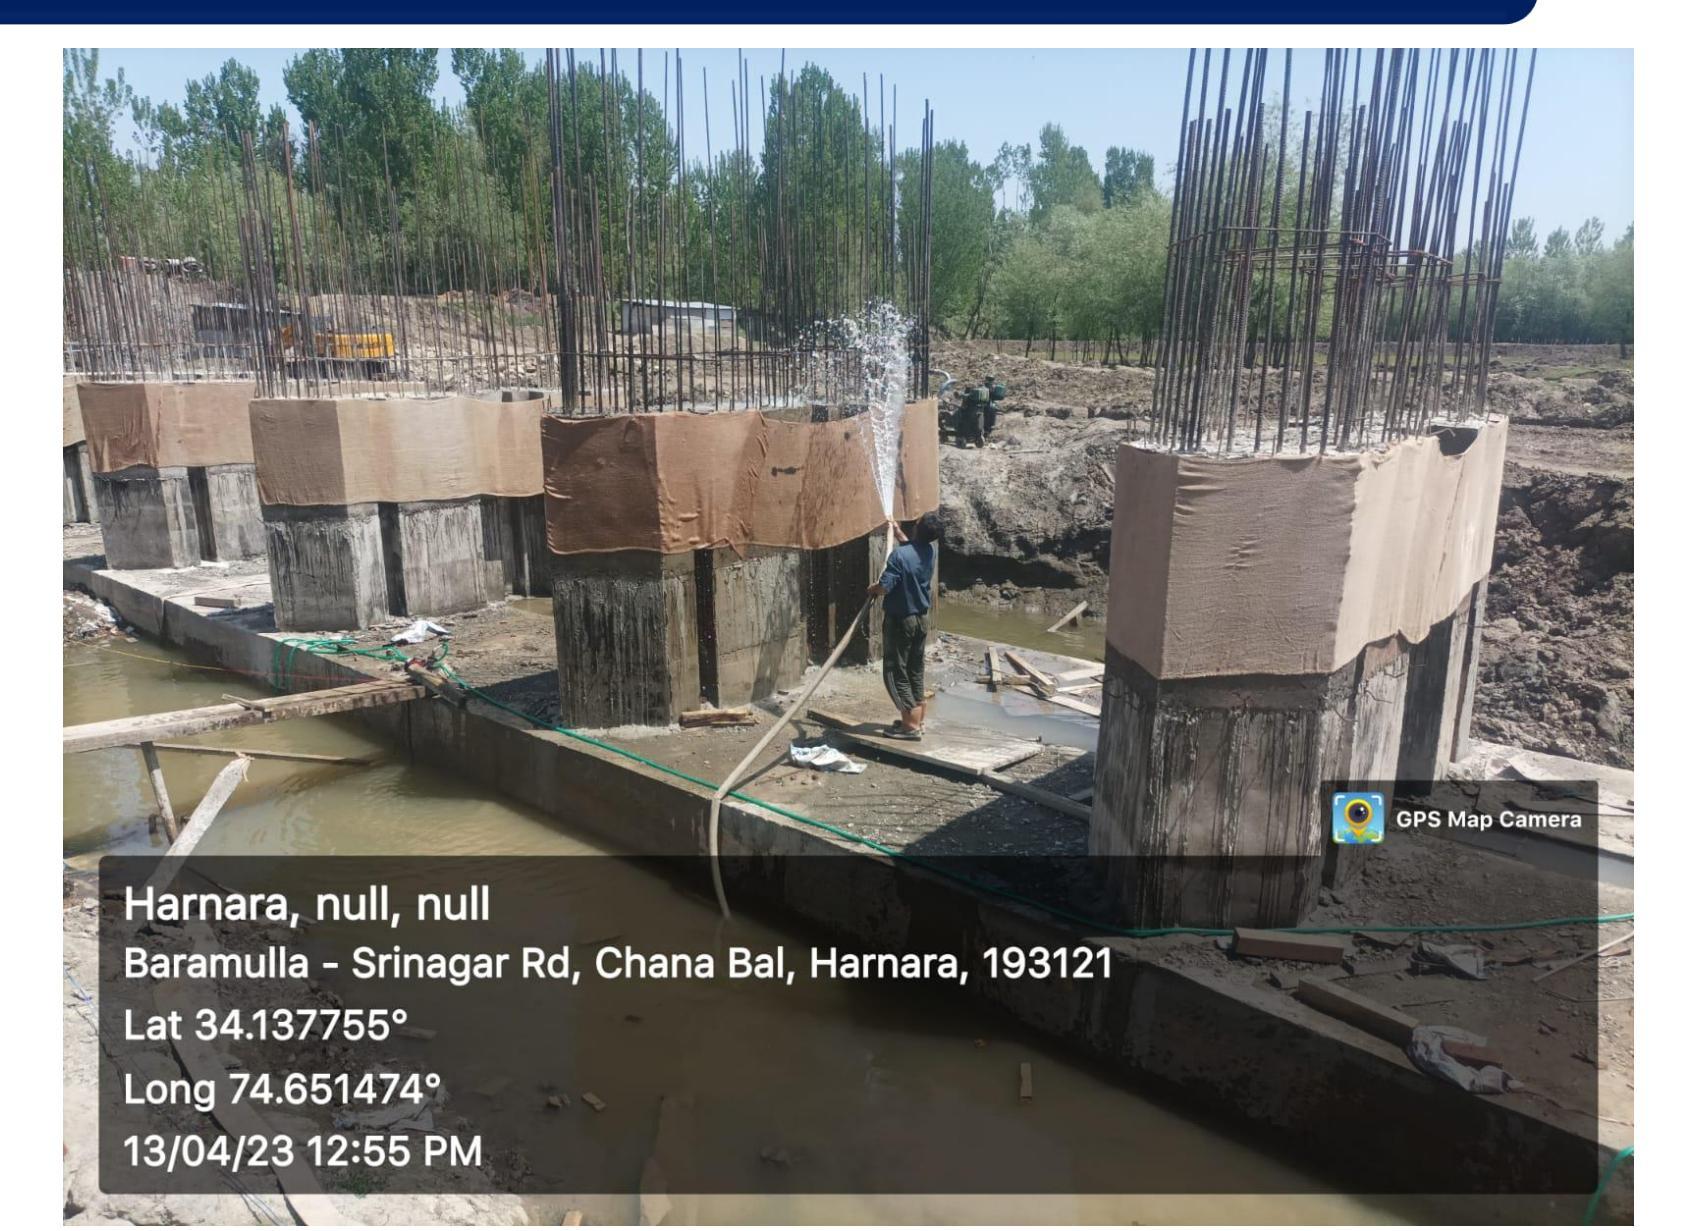
# **Construction of Piers**

•34 piers (17 at each gate) were built to support the hydraulic gates, involving formwork, concrete pouring, and curing.

•The piers were carefully aligned and strengthened to ensure they met design specifications.
