Mechanical Equipments used in Irrigation

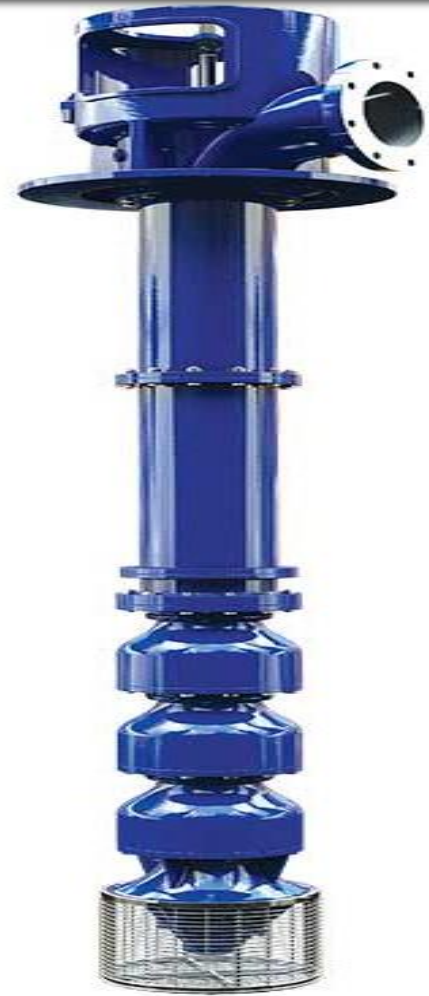
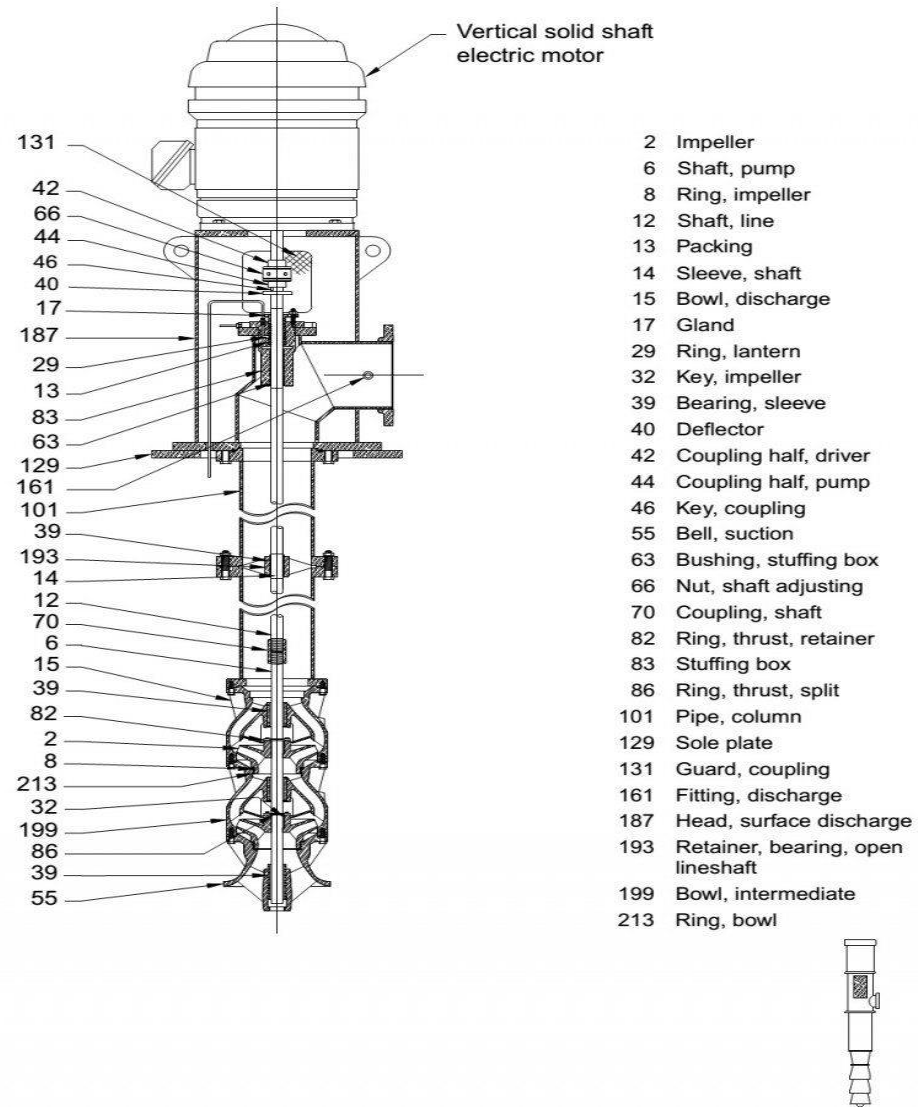
Vertical Turbine Pump

Figure 2.1.3.2a — Vertical single or multistage, short setting, open lineshaft (VS1)

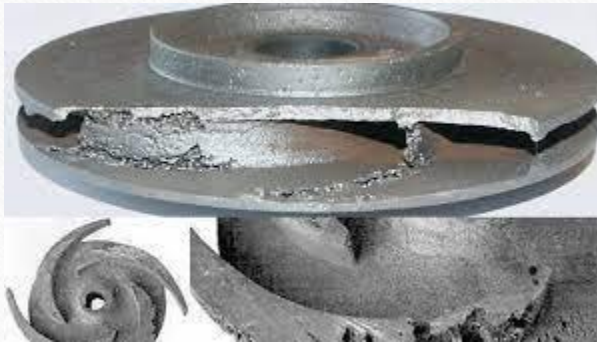
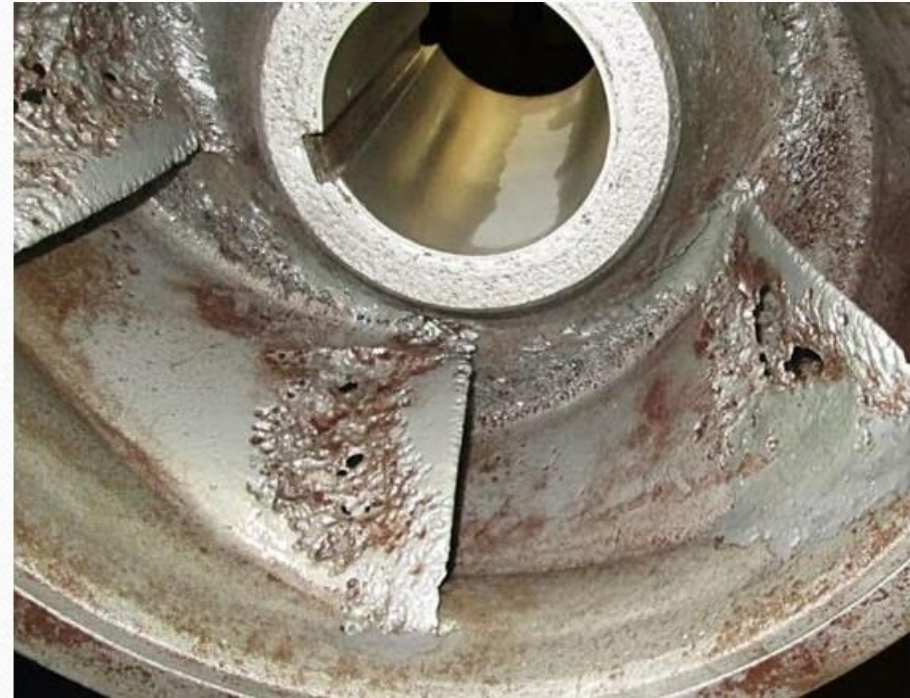
CAVITATION

- insufficient pressure at the suction end of the pump or Net Positive Suction Head Available (NPSHa)
- $NPSHa = 10 - H_v - H_z$
- causing the liquid in a pump to turn into vapour at low pressure.

- At low pressures, this creates air bubbles which implode as the liquid moves from the suction side of the impeller to the delivery side.
- The air bubble implosion generates a shockwave that stresses the pumps' internal surfaces, creating vibration and mechanical damage, and can ultimately result in failure.
- When this occurs repeatedly, cavitation can cause pitting and fractures in the impeller, volutes and casing, weakening the metal, increasing resistance to flow and reducing pumping efficiency. The shock loads from cavitation can also decrease the service life of the shaft and motor.
- Cavitation and the related problems it causes can greatly impact the life of a pump, reducing it by 10-15 years, or even more in extreme cases.

- Remedies
 - Cavitation is most easily avoided during the design stage, ensuring the chosen pump will have sufficient NPSHa so that the liquid remains above vapour pressure.
 - The NPSH will need to be calculated for each application as vapour pressure is different for different liquids and varies with pressure and temperature.

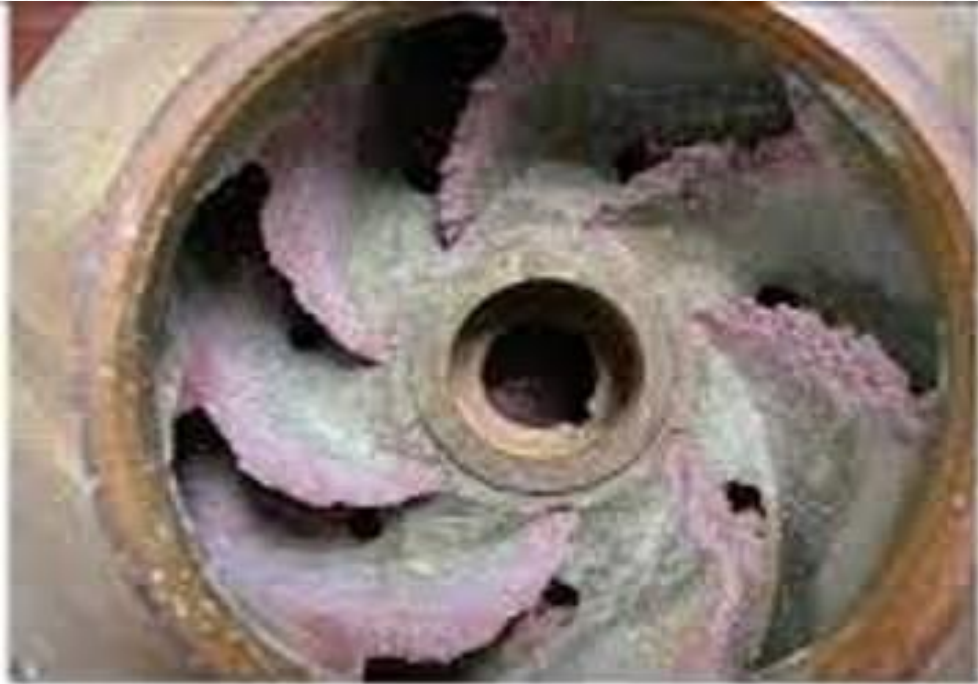
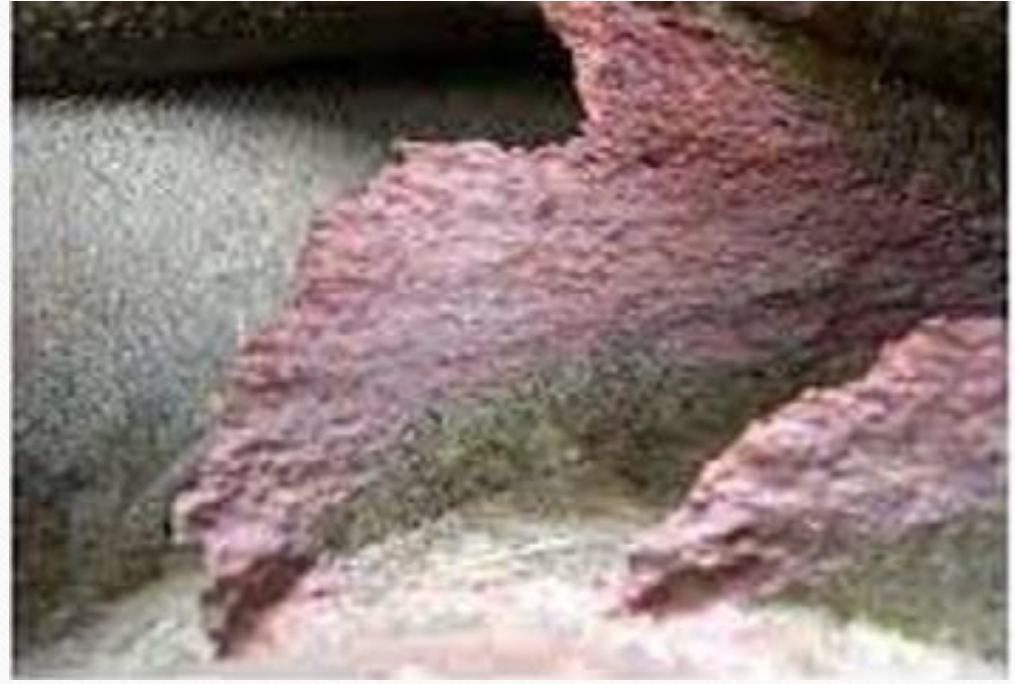
CORROSION

- Causes
- As a result of a chemical reaction between the metal and the fluid being pumped.
- This reaction can cause uniform corrosion of the wet surfaces – found mostly in pumps made from non-stainless steel materials – or localised corrosion of a small portion of the components – occurring most commonly where metals that form oxide layers that adhere to the surface.

- pump performance and efficiency is affected, increasing the need for more frequent maintenance and more downtime, and if left untreated it can lead to failure.
- (Rebuilding with the help of specialized electrodes E308L- high chromium & nickel)

- selecting a pump manufactured from the most appropriate materials for the application.
- Cast iron is amongst the cheapest options for pump materials and is often used for casings. It has good corrosion resistance to neutral and high pH liquids, making it a popular choice for general purpose irrigation pumps
- Stainless steel is one of the most commonly used materials for pumps as it has good corrosion resistance in a wide range of environments where other carbon and low alloy steels would corrode.

- This is not an issue for higher grades of stainless steel, which have a high level of corrosion resistance....however costs are prohibitive.
- Material selection determines the corrosion resistance in a particular application as well as the pump's overall cost, including initial cost, maintenance, replacement, downtime, lifecycle and reliability.

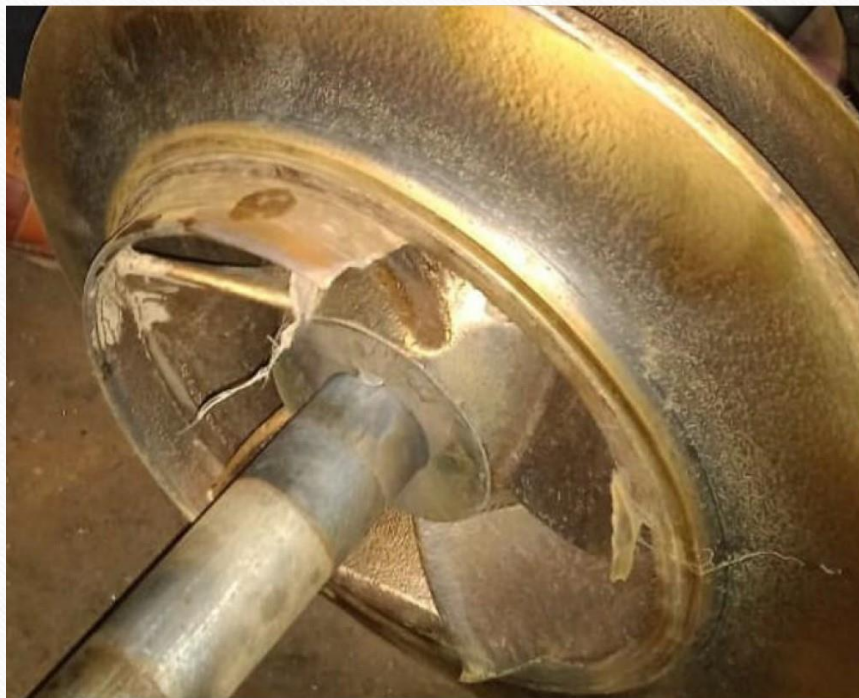
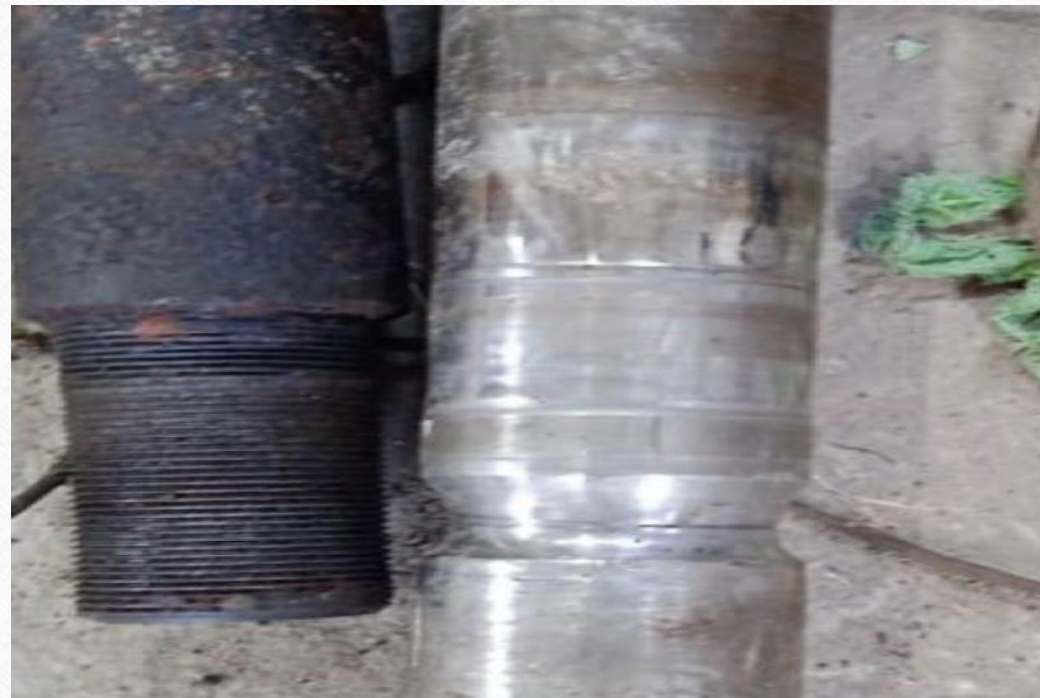
WEAR

- Wear is inevitable when running a pump, however, there are a few factors that can cause excessive wear, speeding up deterioration of the pump.
- Particulate matter (>850 micron) in the pumped fluid can lead not only to fouling but also increases the pace of wear on a pump. These particulates scour a pump's interior surfaces and roughens them, reducing pumping efficiency over time as it needs to work harder to move the fluid.

- Effect
- the pump becomes so worn that it is unable to produce enough lift and may cause excessive vibration which has damaging percolating effect i.e. undue breaking of coupling bolts, couplings, bearings, etc.

- Remedy
- Wear rate can be slowed down by ensuring the pump size and materials are suitable for the application, and regular maintenance is carried out to find and fix any problems before they result in unexpected downtime or pump failure.

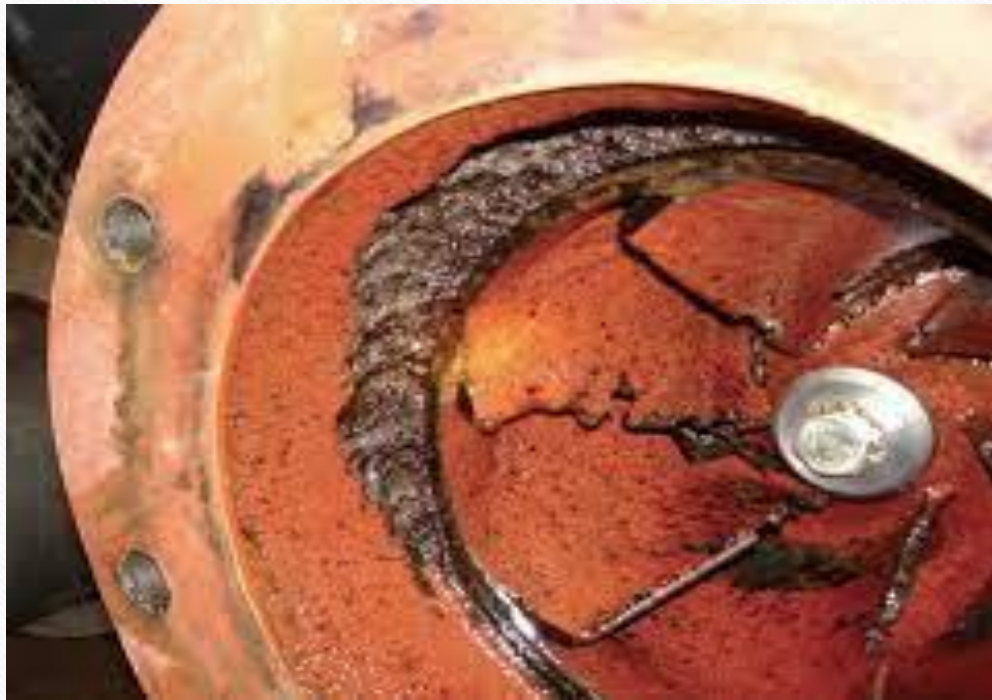
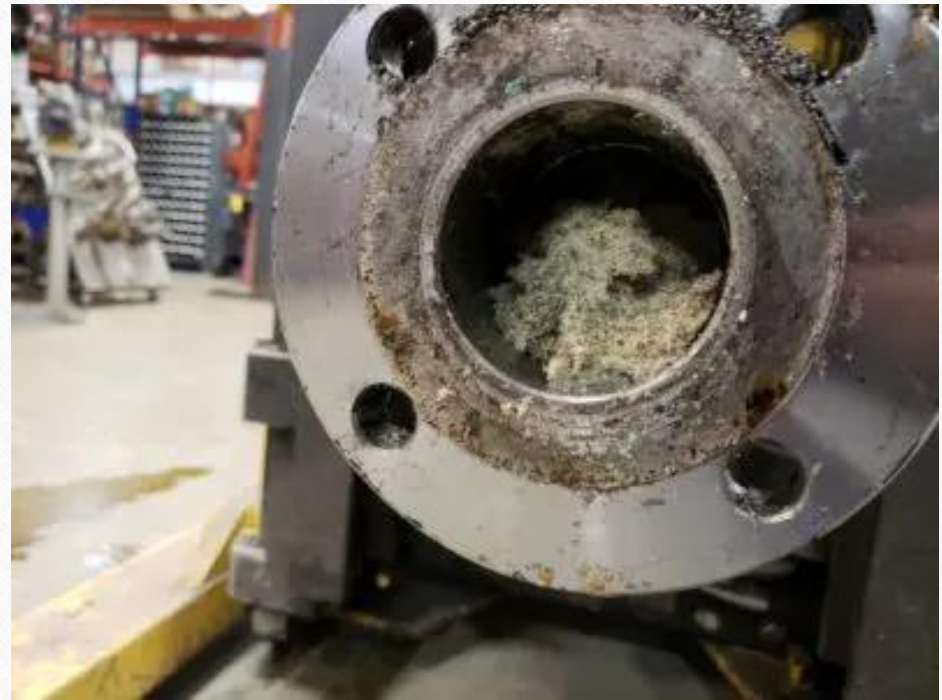
FOULING

- Cause
 - Fouling occurs when particulate matter adheres to a pump's internal surfaces, most commonly in the distribution lines connected to the intake or outflow.
- Effect
 - pumping efficiency and flow capacity are decreased, and may eventually lead to failure.

- Remedy
- This is an unavoidable problem, but is more prevalent in applications where the fluid being pumped contains particles.
- However, cleaning as required is done to maintain the pump and improve efficiency and capacity.
